TERMS OF REFERENCE FOR THE INVESTIGATION OF THE DEATHS OF SIYABONGA MABILA AND LAWRENCE TSHWENU

**The construction of Road K54 between
K22 (old Bronkhorstspruit Road) and
K69 (Solomon Mahlangu) as well as a
section of Road 2561 from K54 to
Tsamaya Road in Mamelodi**

Occupational Health and Safety Incident Investigation Report: The construction of Road K54 between K22 (old Bronkhorstspruit Road) and K69 (Solomon Mahlangu) as well as a section of Road 2561 from K54 to Tsamaya Road in Mamelodi

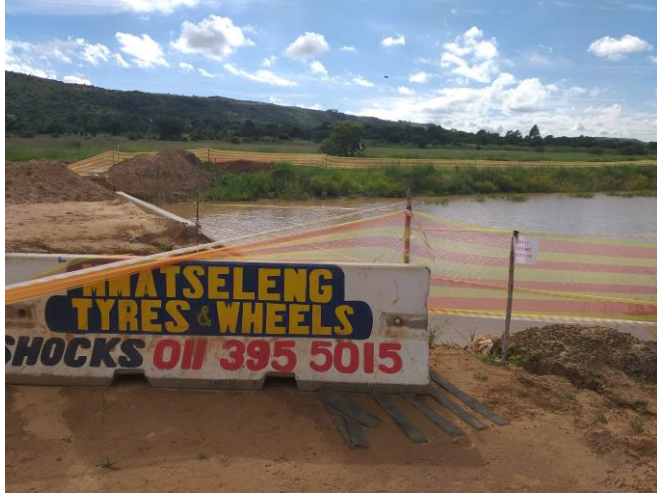
P1

Water ponding was identified on site. This causes the risk of members of the public / employees sustaining serious injuries in the event of falling / drowning.

REF	DEVIATION	IN	CN	PN	REMEDIAL ACTION	COMPLETION DATE
P1-3	Water ponding was identified on site.		√		Ensure dewatering activities are implemented.	Immediately
P4-8	Numerous employees were identified conducting activities on an unsafe scaffold structure. The unsafe scaffold structure was found erected incorrectly, visibly displaying the correct warning signage "unsafe for use".		√		Ensure scaffold is erected correctly and only safe and inspected scaffold structures are used, visibly displaying the required warning signage indicating the status of the structure.	Immediately

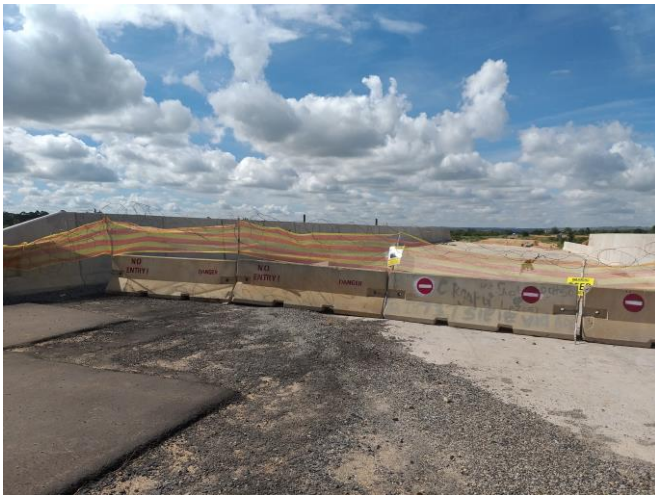
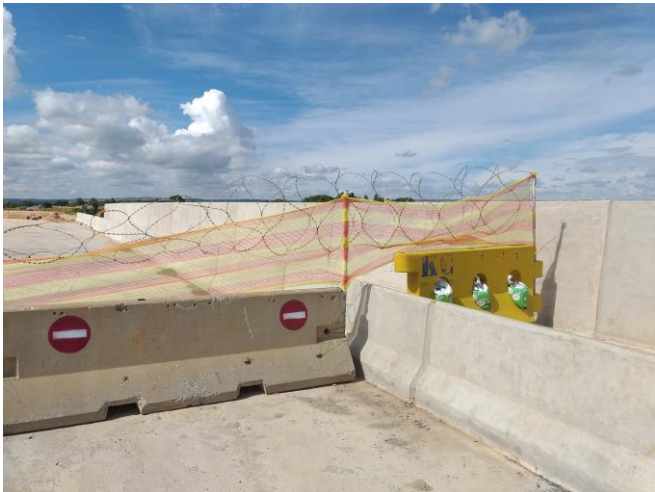
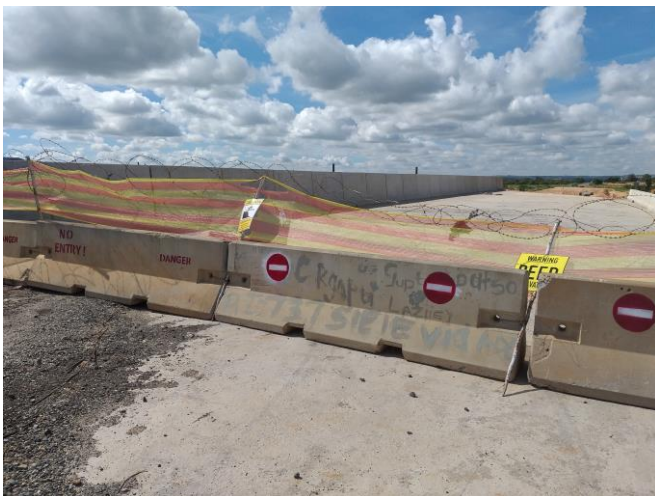
OBSERVATION:
Photo 4-6

First bridge was found barricaded at the top with sand piles placed and barriers used to prevent people from driving on bridge road.

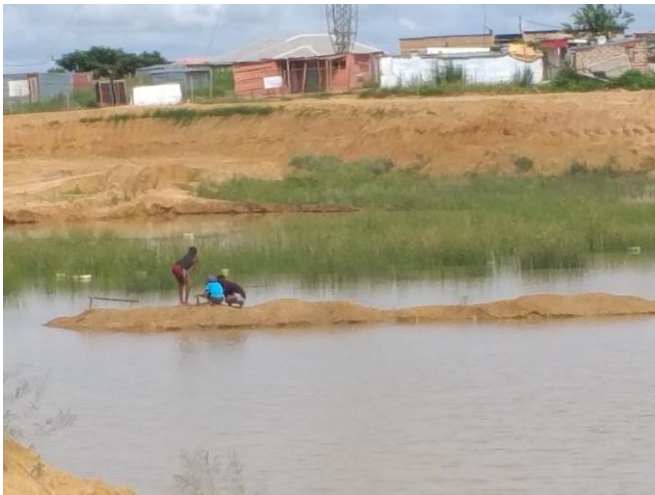
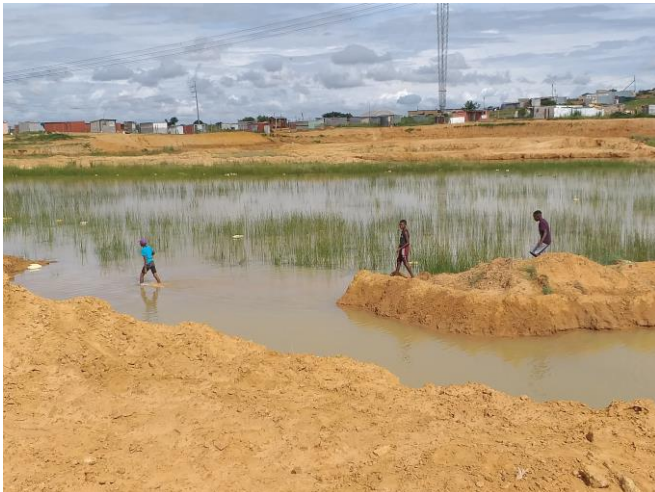
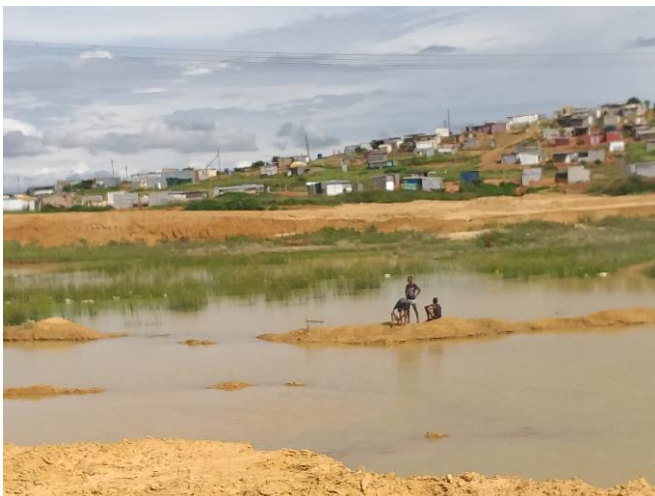
OBSERVATION:
Photos 7-10

No access management was identified implemented at the main entrance to site e.g. children were found playing in water environment. This causes the risk of members of the public sustaining serious injuries in the event of unauthorized access to construction site / children drowning resulting in public liability claims.

REF	DEVIATION	IN	CN	PN	REMEDIAL ACTION	COMPLETION DATE
P7-10	No access management was identified implemented at the main entrance to site e.g. children were found playing in water environment.			✓	Ensure access management is implemented and maintained and that if the safety guard has to leave his post, he is relieved and the entrance is not left unattended.	Immediately
P11-14	Numerous excavations were identified not barricaded with solid barricading.		✓		Ensure excavations are barricaded with solid barricading, visibly displaying the required safety warning signage.	Immediately

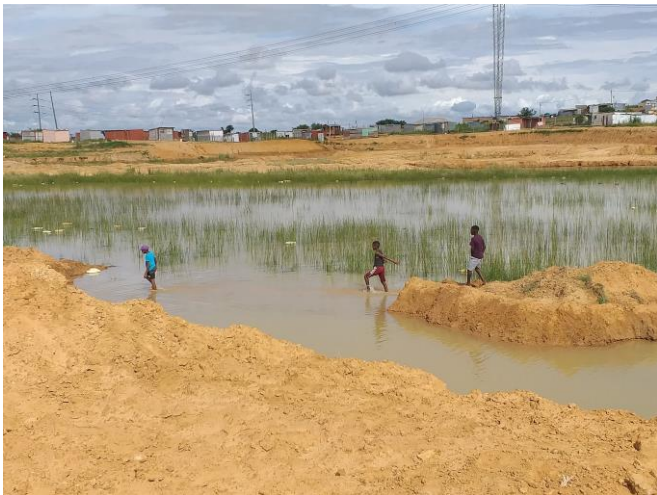
P10

OBSERVATION:
Photo 10

No access management was identified implemented at the main entrance to site e.g. children were found playing in water environment. This causes the risk of members of the public sustaining serious injuries in the event of unauthorized access to construction site / children drowning resulting in public liability claims.

REMEDIAL ACTIONS:

Ensure access management is implemented and maintained and that if the safety guard has to leave his post, he is relieved and the entrance is not left unattended.

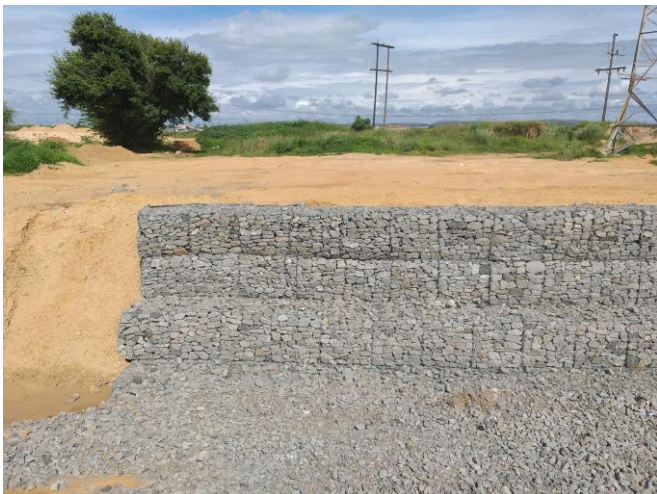
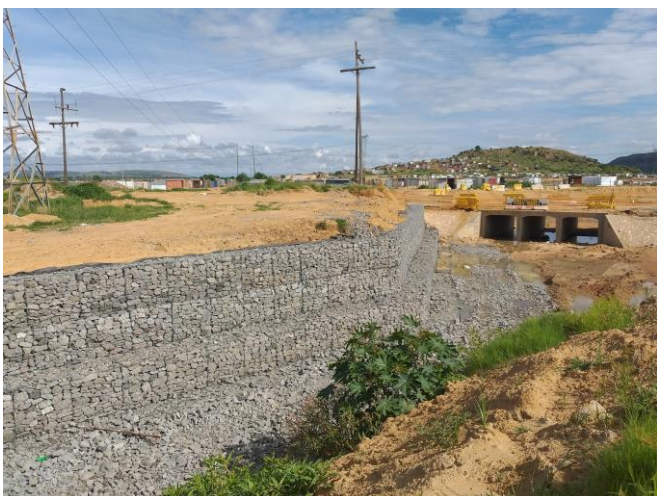
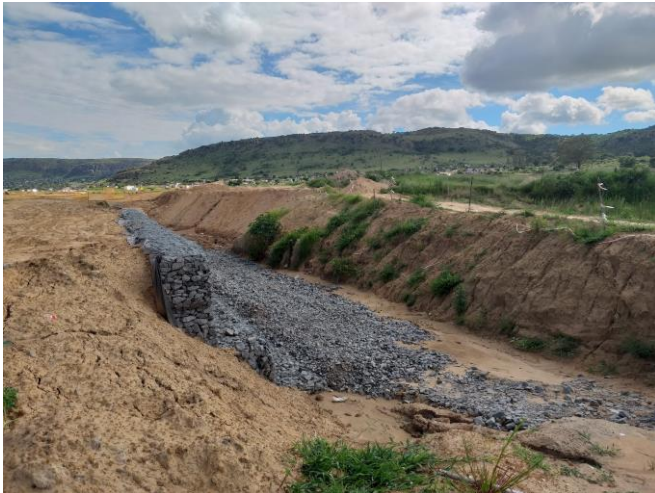
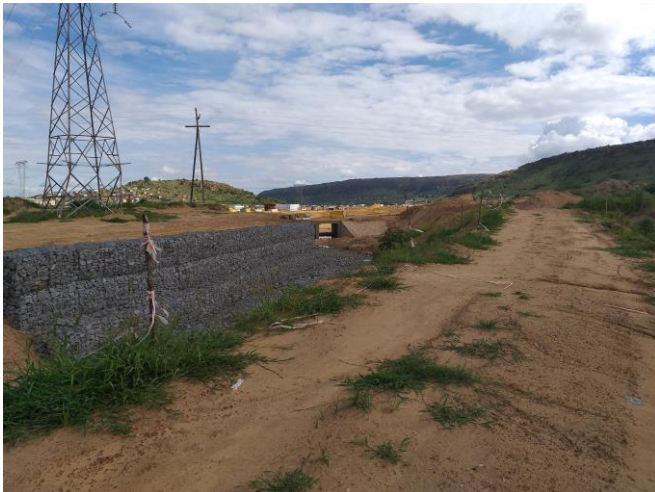
OBSERVATION:
Photos 11-14

Numerous excavations were identified not barricaded with solid barricading. This causes the risk of employees sustaining serious injuries in the event of falling.

REMEDIAL ACTION:

Ensure excavations are barricaded with solid barricading, visibly displaying the required safety warning signage.

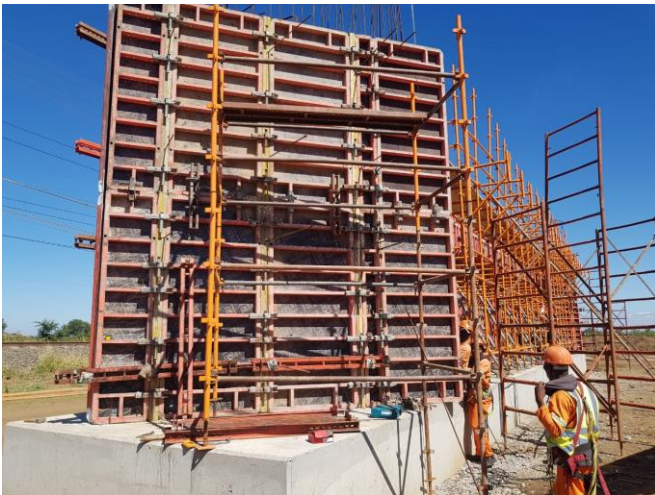
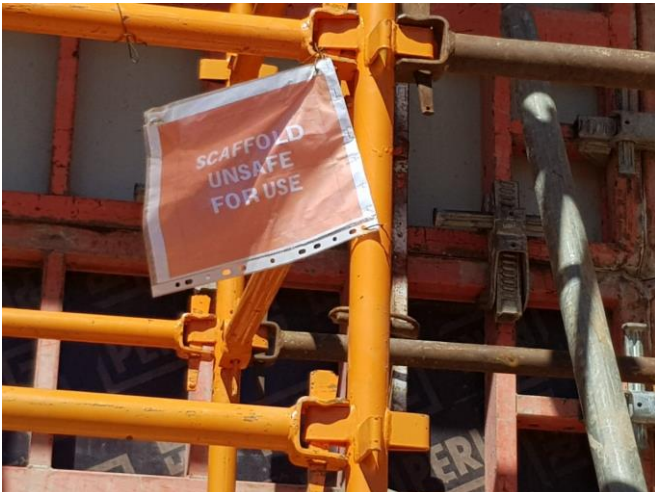
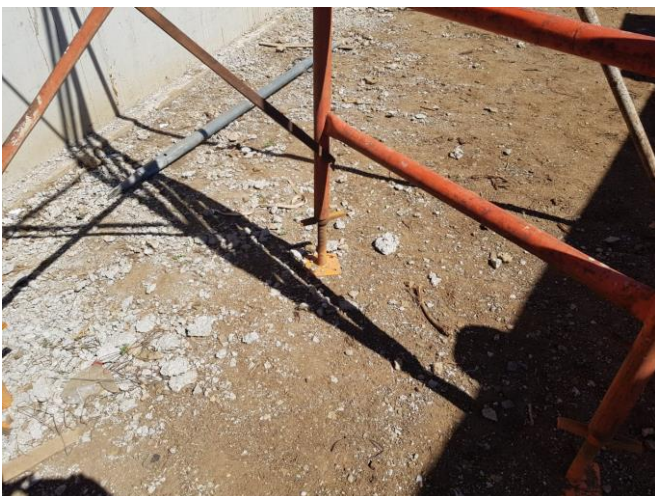
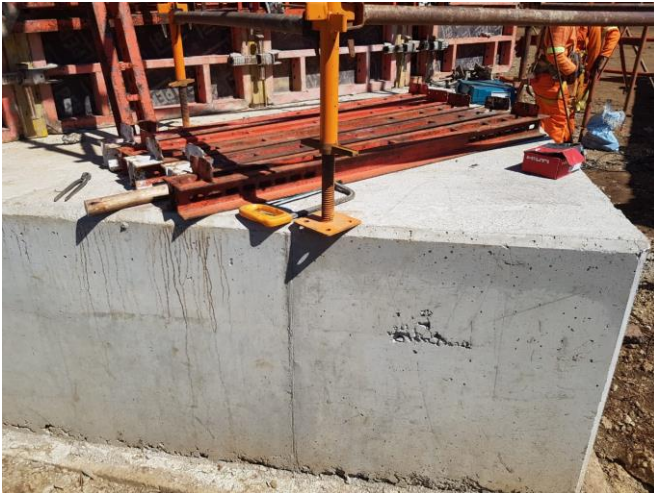
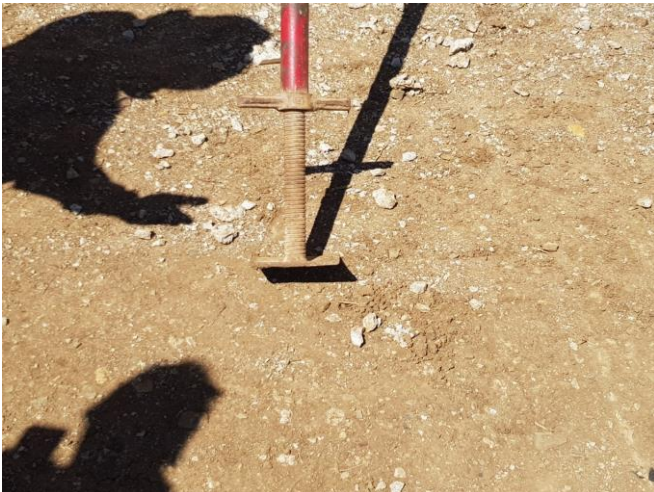
OBSERVATION:
Photos 4-8

Numerous employees were identified conducting activities on an unsafe scaffold structure. The unsafe scaffold structure was found erected incorrectly, visibly displaying the correct warning signage “unsafe for use” This causes the risk of employees sustaining serious injuries in the event of falling / structure collapsing.

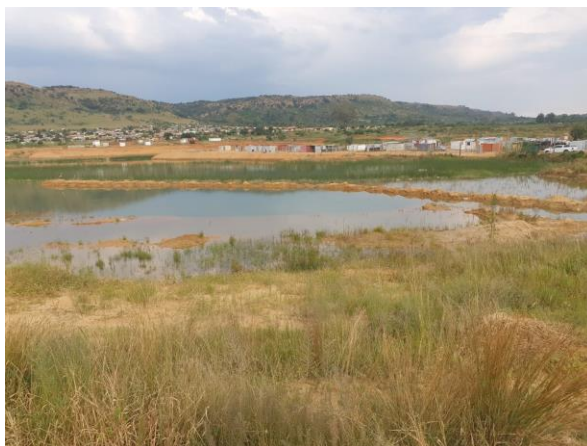
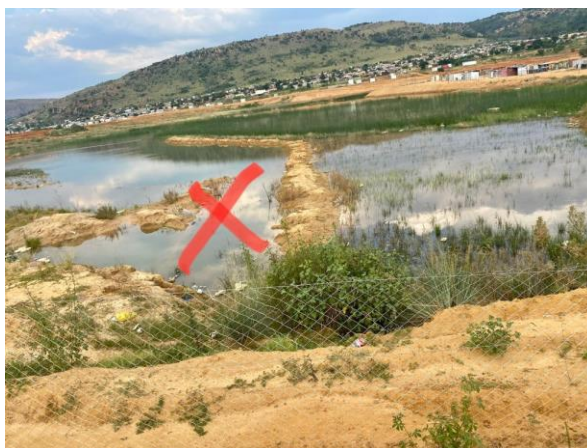
Please see the following photos of the location where the incident took place –

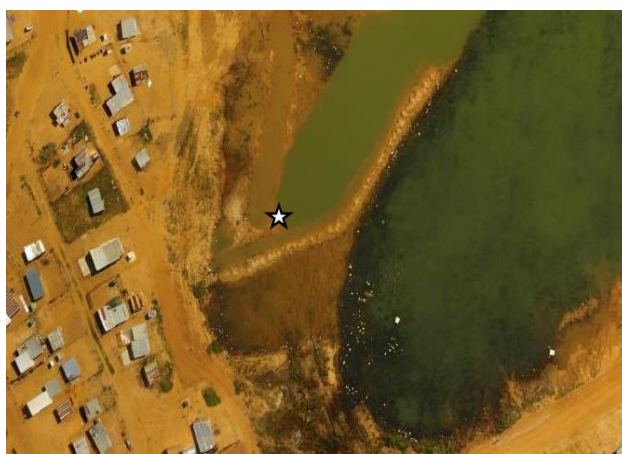
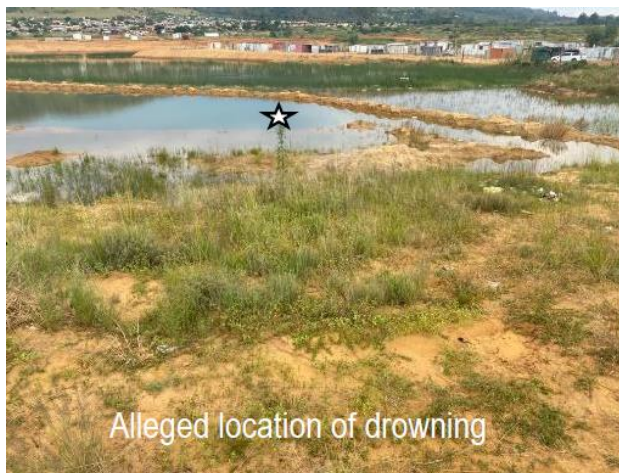
Please see the following photos where the incident took place (i.e. marked with a white star). It is evident from the following photos that the excavations that formed the wetland are historical due to previous illegal mining activities and not as a result of King Civil's construction activities.

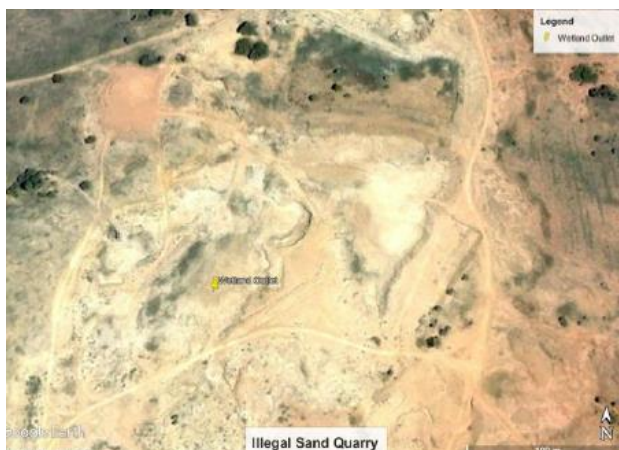
Please note the footprint of the wetland area as far back as February 2004 (this imaged was sourced from Google Maps history)

- a. The Wetland and in specific the location where the incident occurred was formed/caused by illegal sand mining activities traceable as far back as February 2004 (see Annexure E for a pictorial overview of how the illegal mining activities impacted on the land over the past two decades);

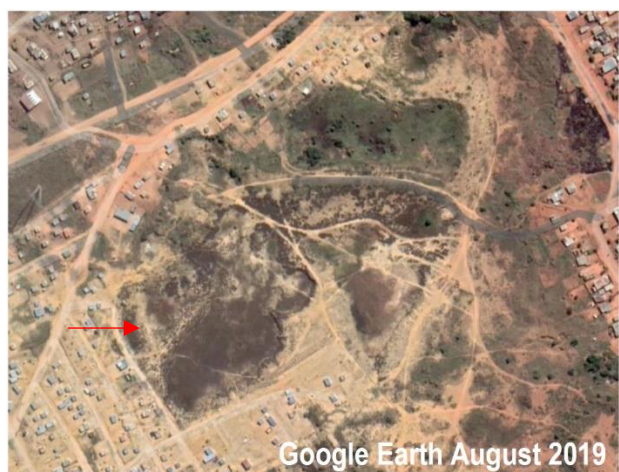
Note the footprint of the wetland area in August 2019

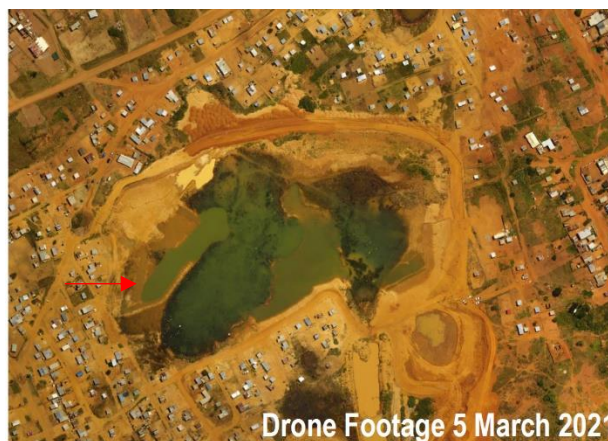
Please note the footprint of the same wetland area on 05 March 2021 indicating its unaltered footprint.

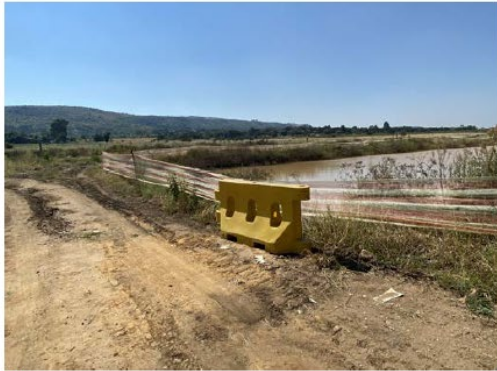
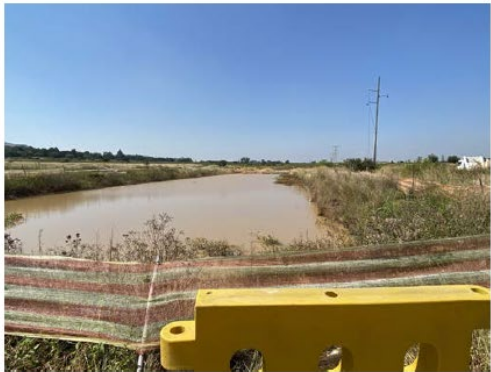
OBSERVATION:
Photos 4-6

REMEDIAL ACTIONS:

Ensure that all construction water ponding areas are barricaded with solid barricading and ensure that barricading is maintained at all times.

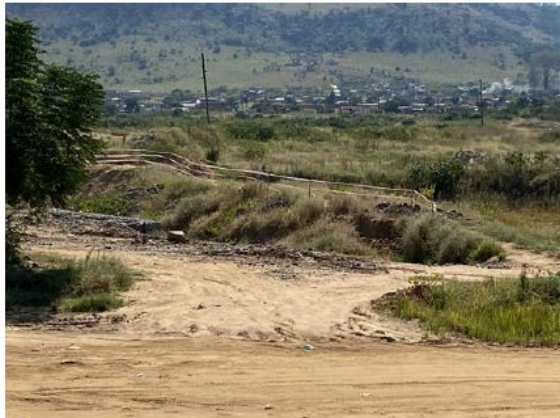
P2

OBSERVATION:
Photos 2-6
