**THE PERILS OF DEPRIVATION:
BETRAYED AND DROWNED BY TREACHEROUS EXCAVATIONS**

**INVESTIGATIONS INTO THE TRAGIC DEATHS OF SIYABONGA MABILA, AGED 7 AND
LAWRENCE TSHWENU, AGED 4, IN PIENAARSPORT EXTENSION 20 MAMELODI TSHWANE**

**TJB BOKABA SC
SEPTEMBER 2021**

**PRESENTED TO: MEC FOR GAUTENG DEPARTMENT
OF ROADS AND TRANSPORT:
MR JACOB MAMABOLO**

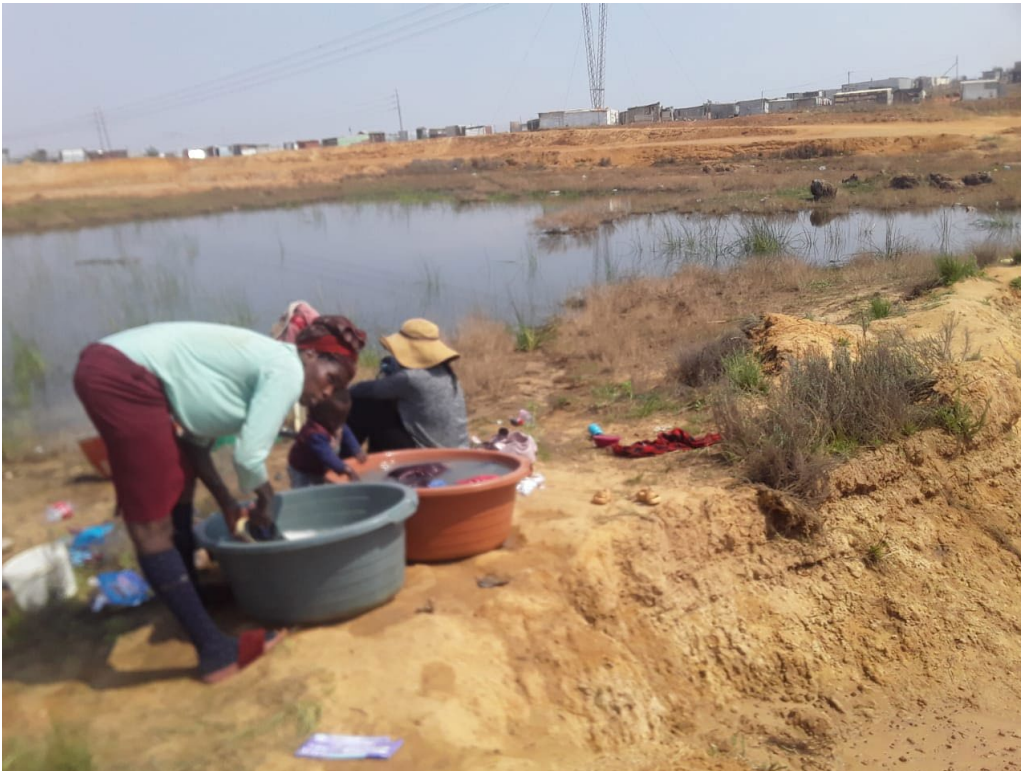
[Pic: Taken by Mr Sidu depicting community members using pond to do laundry.]

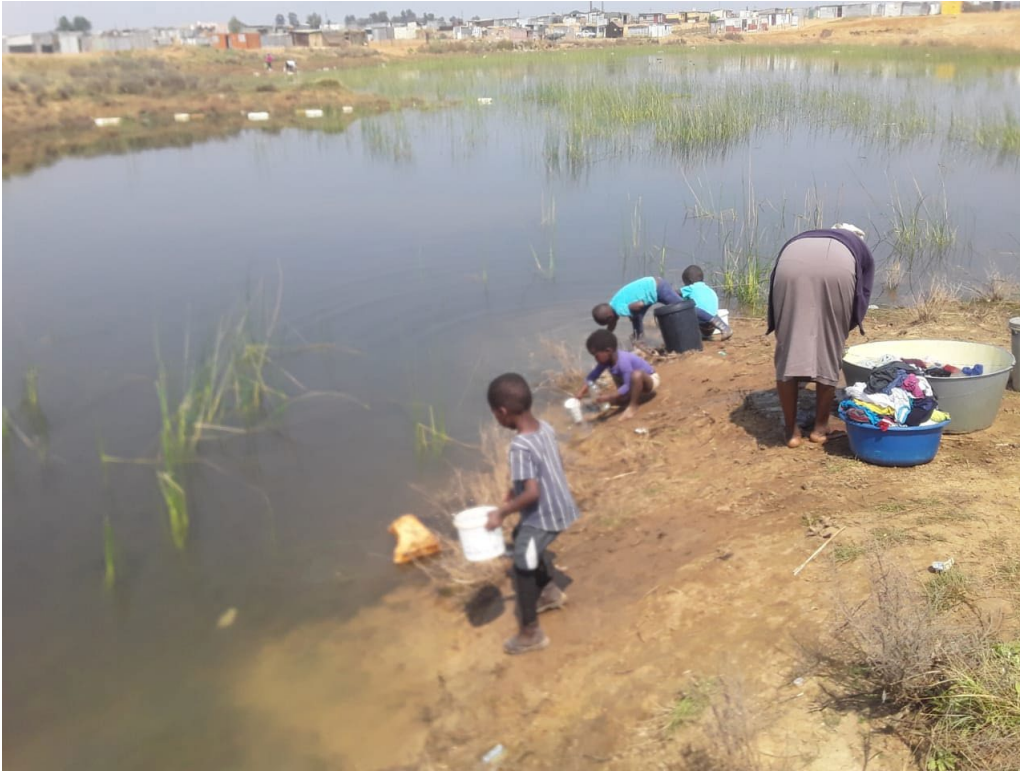
[Pic: Taken by Mr Sidu depicting children in the pond.]

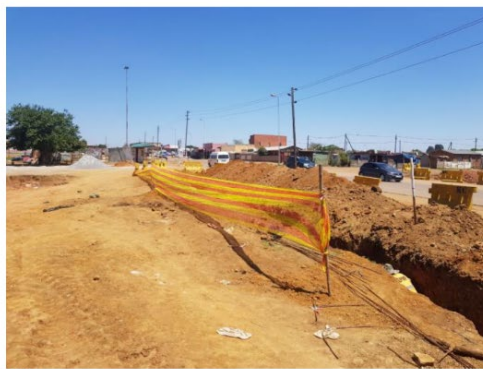
P10

OBSERVATION:
Photos 10-12

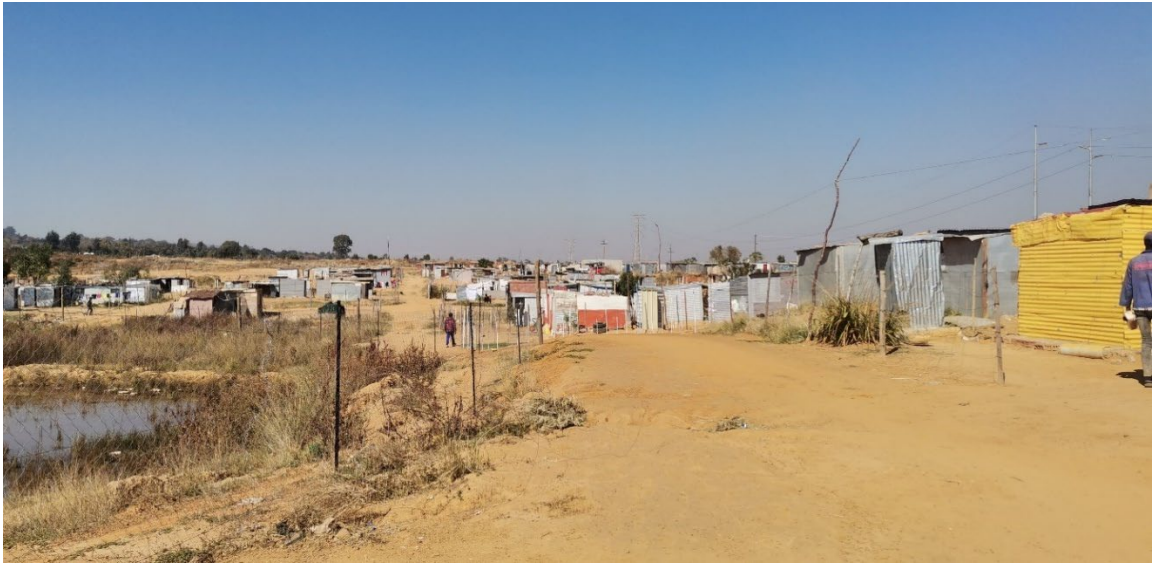
444.4.2 In fact, the encroachment is so significant that King Civil no longer has access to the pond for construction purposes or to perform the necessary work in terms of the drawings and

[Pic: Taken by Investigation Team during inspection in loco demonstrating proximity of illegal dwellings to the water.]

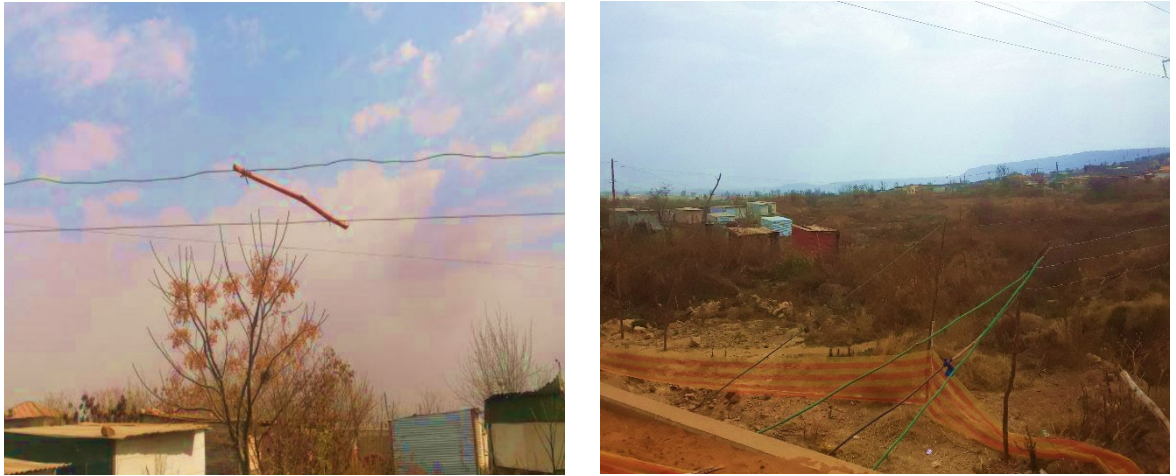
444.4.3 There are many illegal electrical connections running everywhere. These are obviously dangerous for the community, particularly children. They are also a hinderance to the construction works as equipment cannot be used safely.

[Pic: Taken by BoTong during technical inspection depicting extent of illegal electrical connections.]
